Soil and Crop Damages as a Result of Levee Breaches on Ohio and Mississippi Rivers

Kenneth R. Olson¹ and Lois Wright Morton²

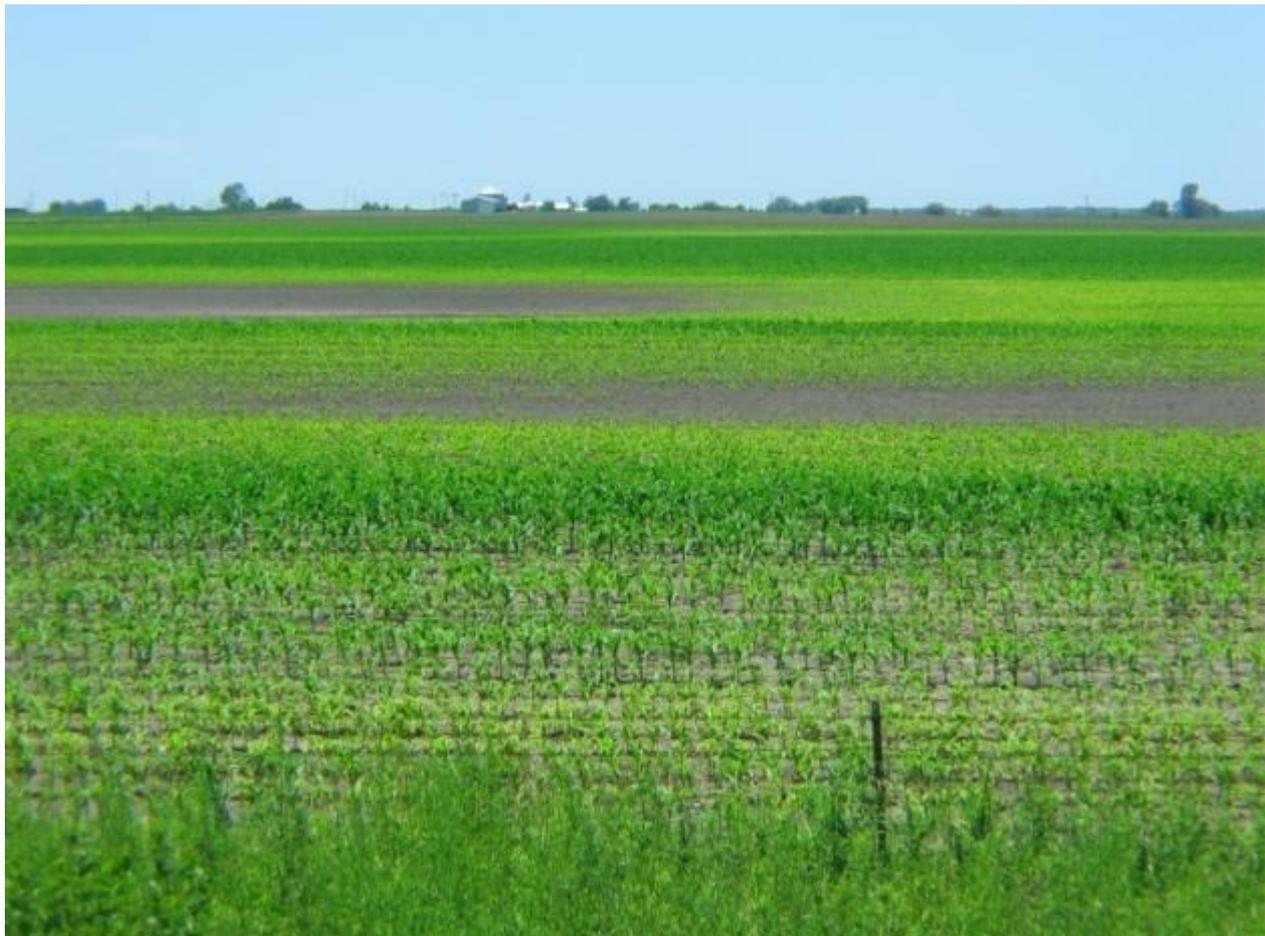
Fig. 2 Effects of ponding and flooding on corn plant populations.

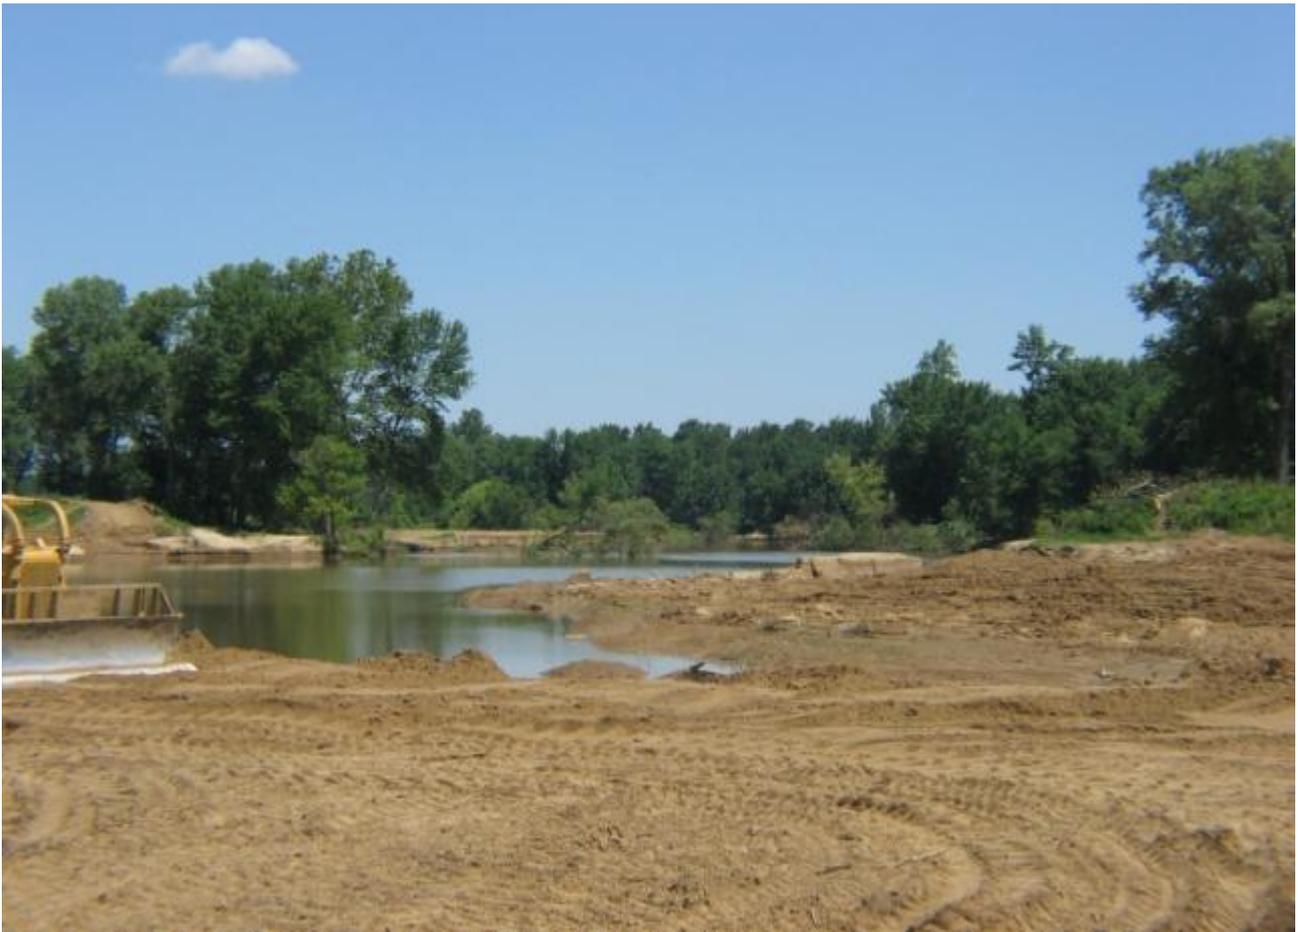
Fig. 3 Levee breach on Embarras River.

This situation happened at two levee breaks southeast of Sainte Marie, IL. About 90 m of levee was lost at each break. Blow-out holes or craters were created that were 0.5 ha to 2 ha in size and held water (Fig. 4). Two to three meter deep gullies extended a few hundred meters into the previously protected floodplain and hundreds of 20-25 m high trees were transported hundreds to thousands of meters onto the now unprotected floodplain. Deltaic sand deposits up to 0.6 m thick covered 25 ha or more on the floodplain at each site (Fig. 5) with an additional 80 ha covered with a few centimeters of sand (Fig. 6). The remaining

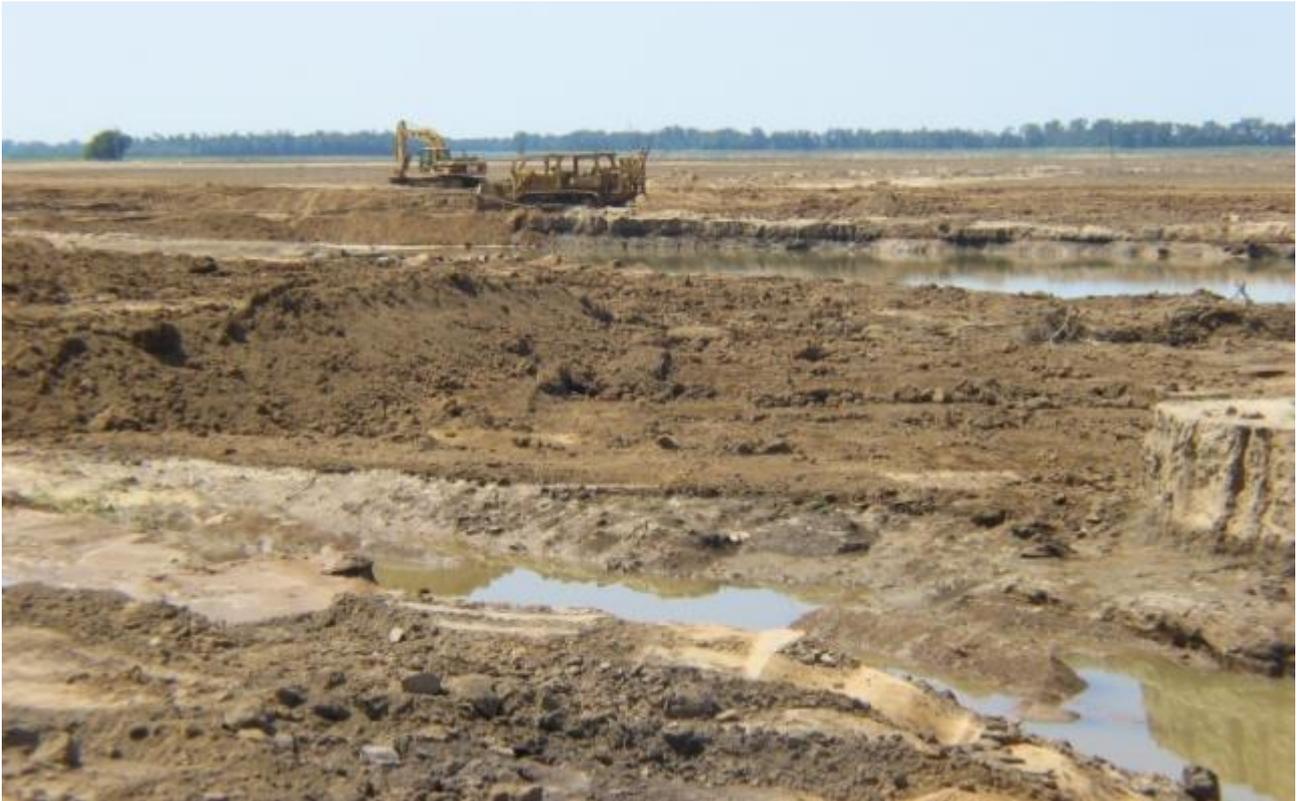
Fig. 4 Crater lake adjacent to Embarras River and levee being filled in with sand.

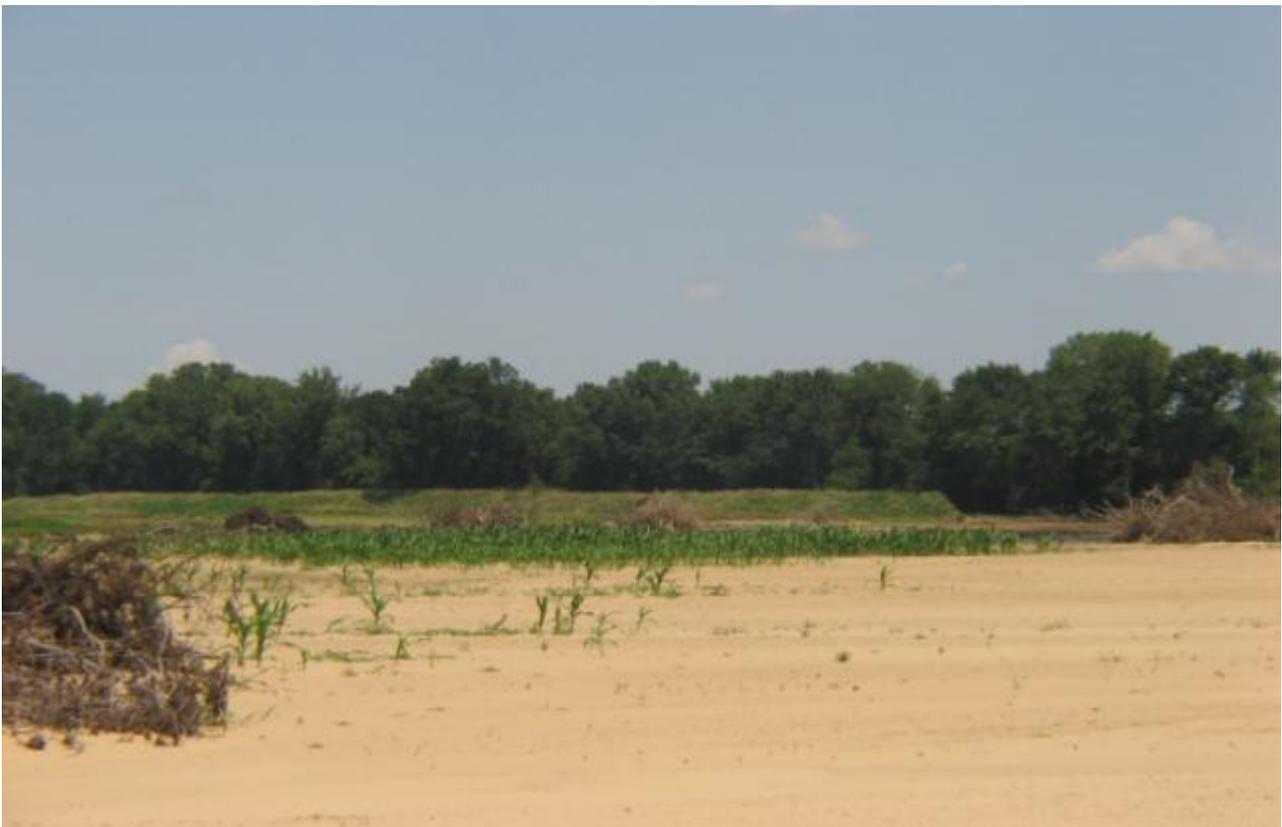
Fig. 5 Embarras River (Illinois) breach and sand deposits in corn field.

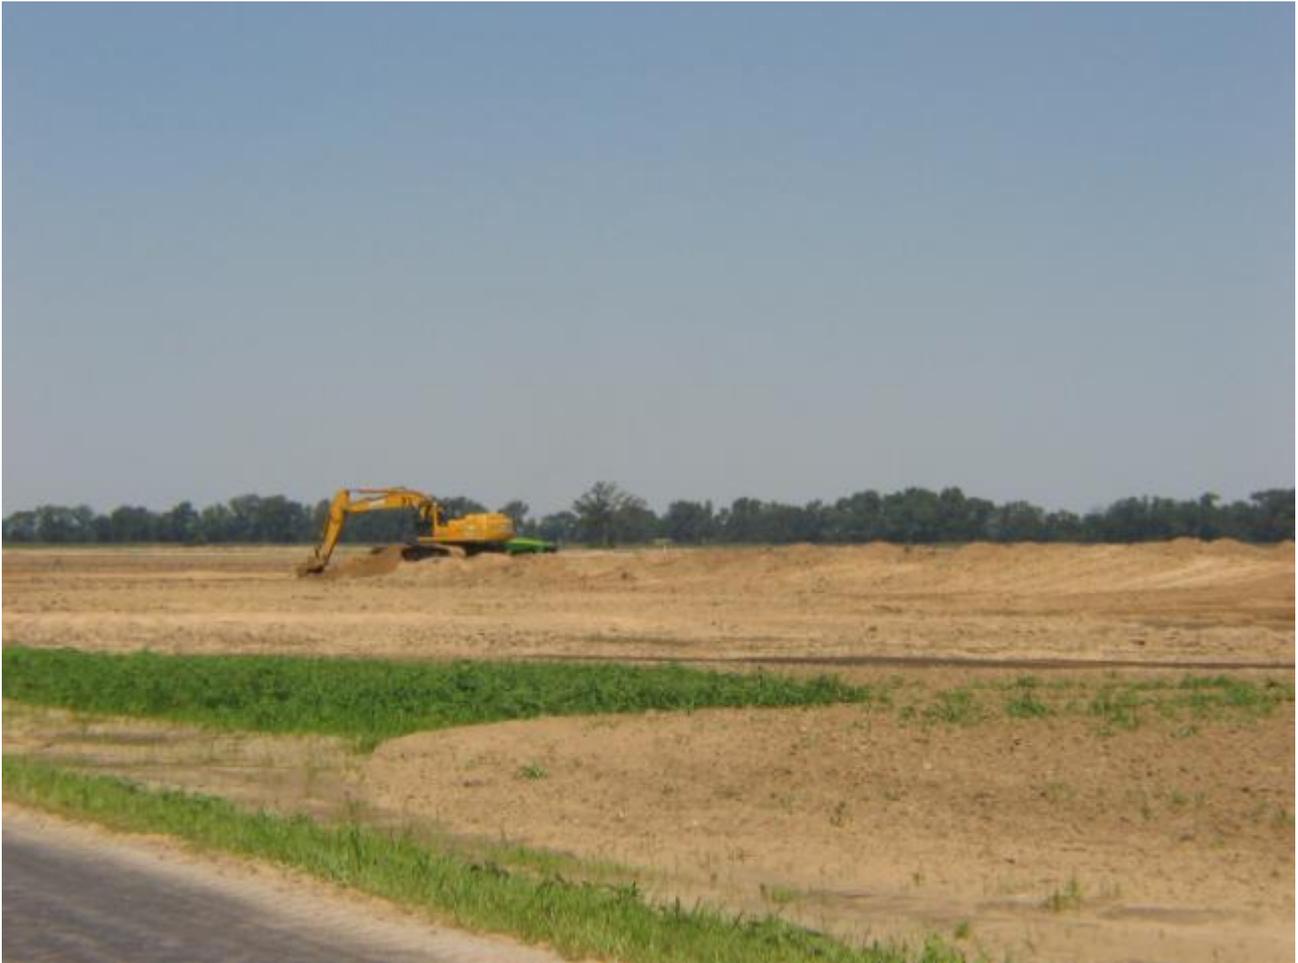
Fig. 6 Sand being piled up and removed from bottomlands (Illinois).

hundreds or thousands of hectares of previously protected floodplain soils received a thin coating of silt and clay and remained under floodwaters long enough to drown out the year's crop. The road and drainage ditches were also filled with sand more than a 1.6 km from the levee break. By June 23, 2008 the water had drained from the floodplains and back into the Embarras River sufficiently for the local farmers to hire contractors with bulldozers, pans, graders, back hoes and buckets to begin the task of moving the trees from near the blow-out holes and floodplain and to begin filling in the craters and gullies.

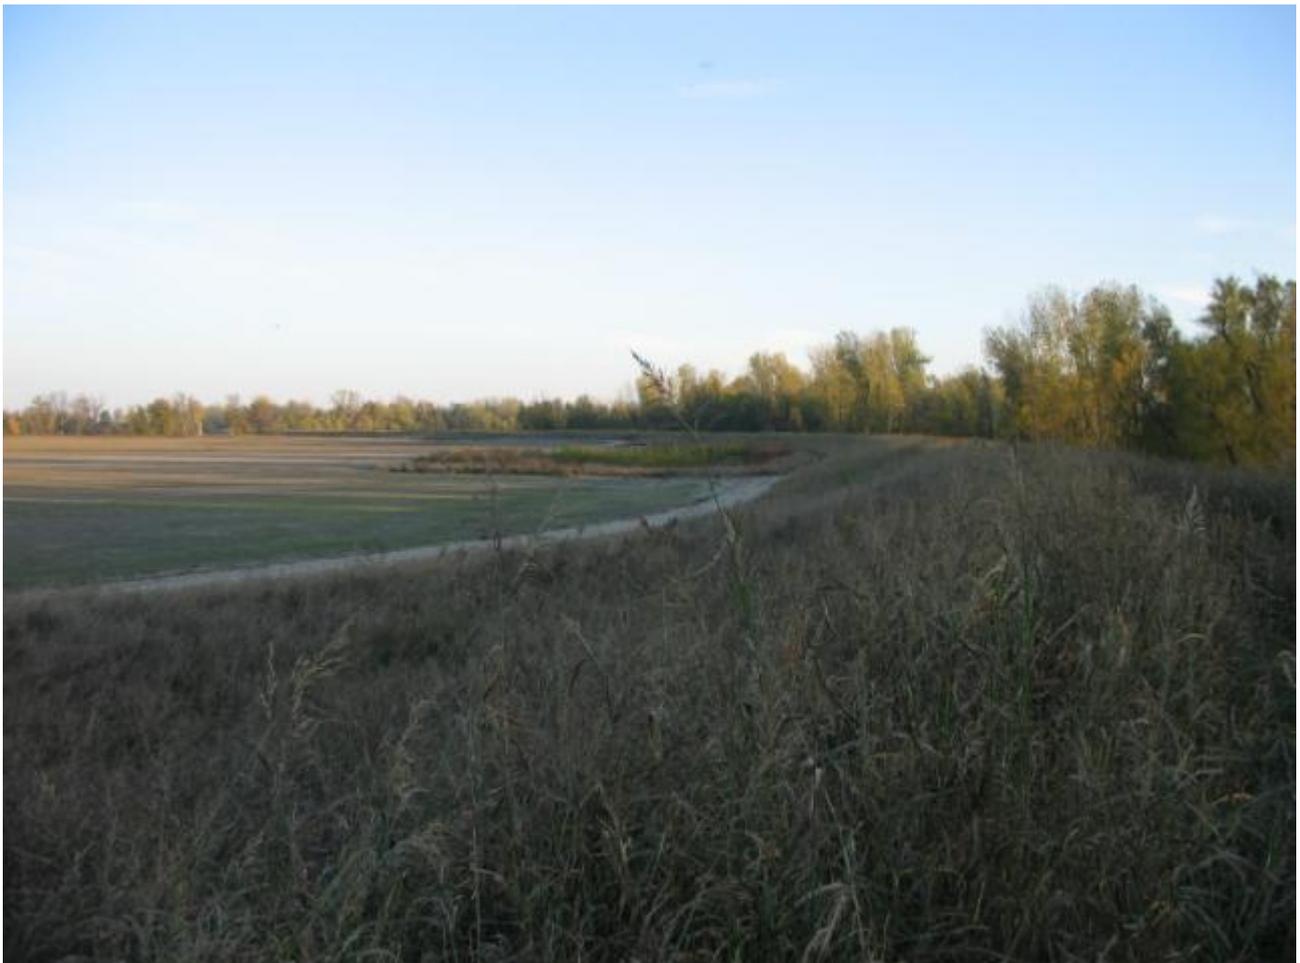
Fig. 7 Len Small farmer district levee near Miller City, Illinois.

Agriculture, the most extensive land use of the Mississippi River Basin over the past 200 years, has altered the hydrologic cycle and changed the regional energy budget [13]. Extensive systems of public and private levees along the Mississippi River near Cape Girardeau, Missouri and southward channel the river and protect low-lying agricultural lands, rural towns, and public conservation areas from flooding [7, 13]. The flood of 2011 severely tested these levee systems. One of these critical levees, the Len Small (Fig. 7), a

private levee, was topped and failed creating a 1,500 m breach as the Mississippi River poured through the gap soursing farmland, depositing sediment, and creating gullies and a crater lake [7]. The Len Small levee and another connecting private levee, the Fayville located in Alexander County on the southwestern Illinois border north of Cairo, were built for 20-year floods. Together they form a 34 km long barrier between the Mississippi River and 24,000 ha of farmland and public land including the Horseshoe Lake Conservation area (Fig. 8) on the western edge of the Cache River Valley.

Levee District patched the Len Small levee by creating a sand berm a meter lower than the original levee. They asked the USACE to cover the levee with a clay cover or cap and restore it to at least the original height. The USACE agreed to do this in August of 2012 after receiving additional federal funds. Some individual farmers created berms around their farmsteads to protect their homes (Fig. 9), barns, out-buildings and equipment from any future flooding that might occur. The repair of the breached levee, crater lake, gullies, and sand deltas began in October of 2011 and continued until November of 2012.

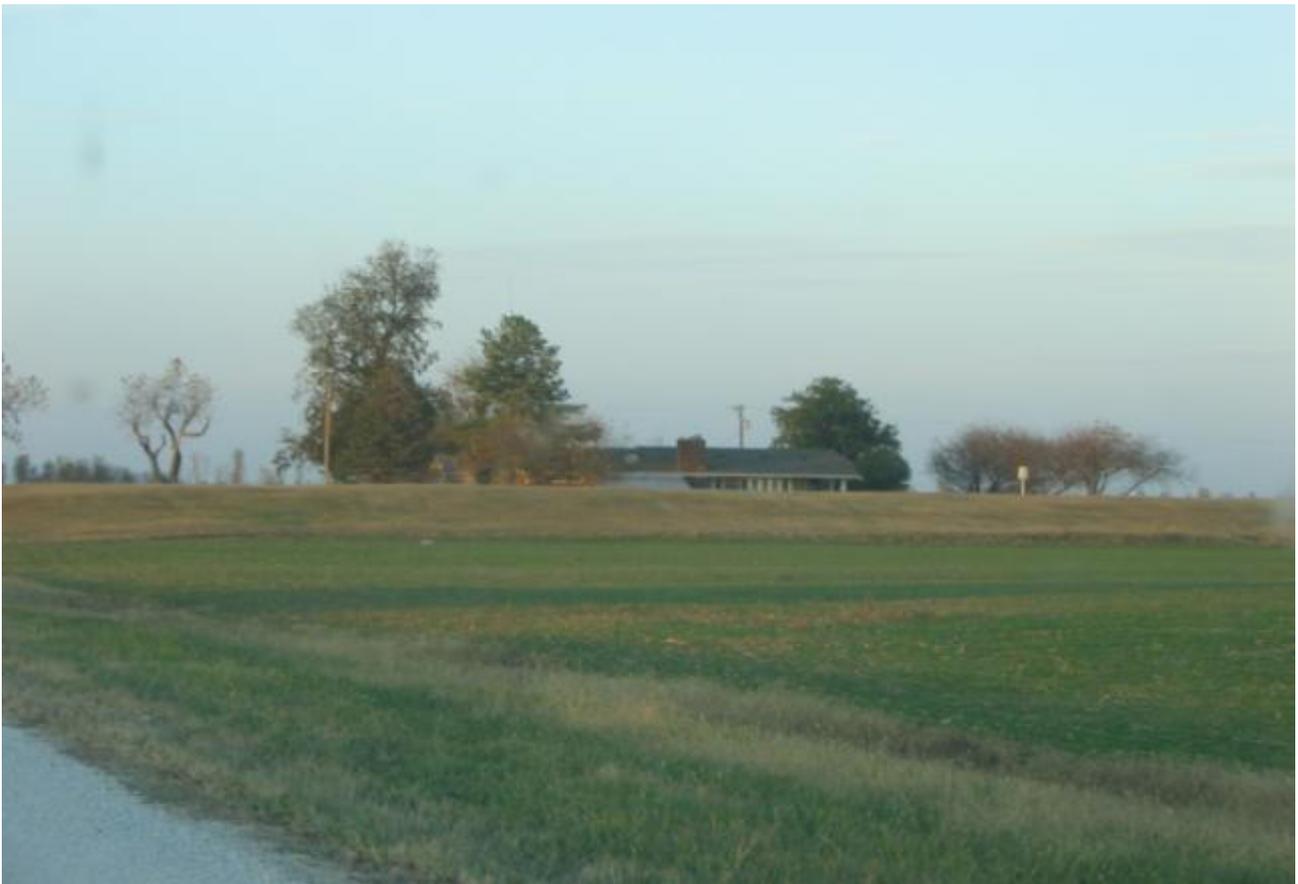
Fig. 9 Berm around home near Miller City, Illinois.

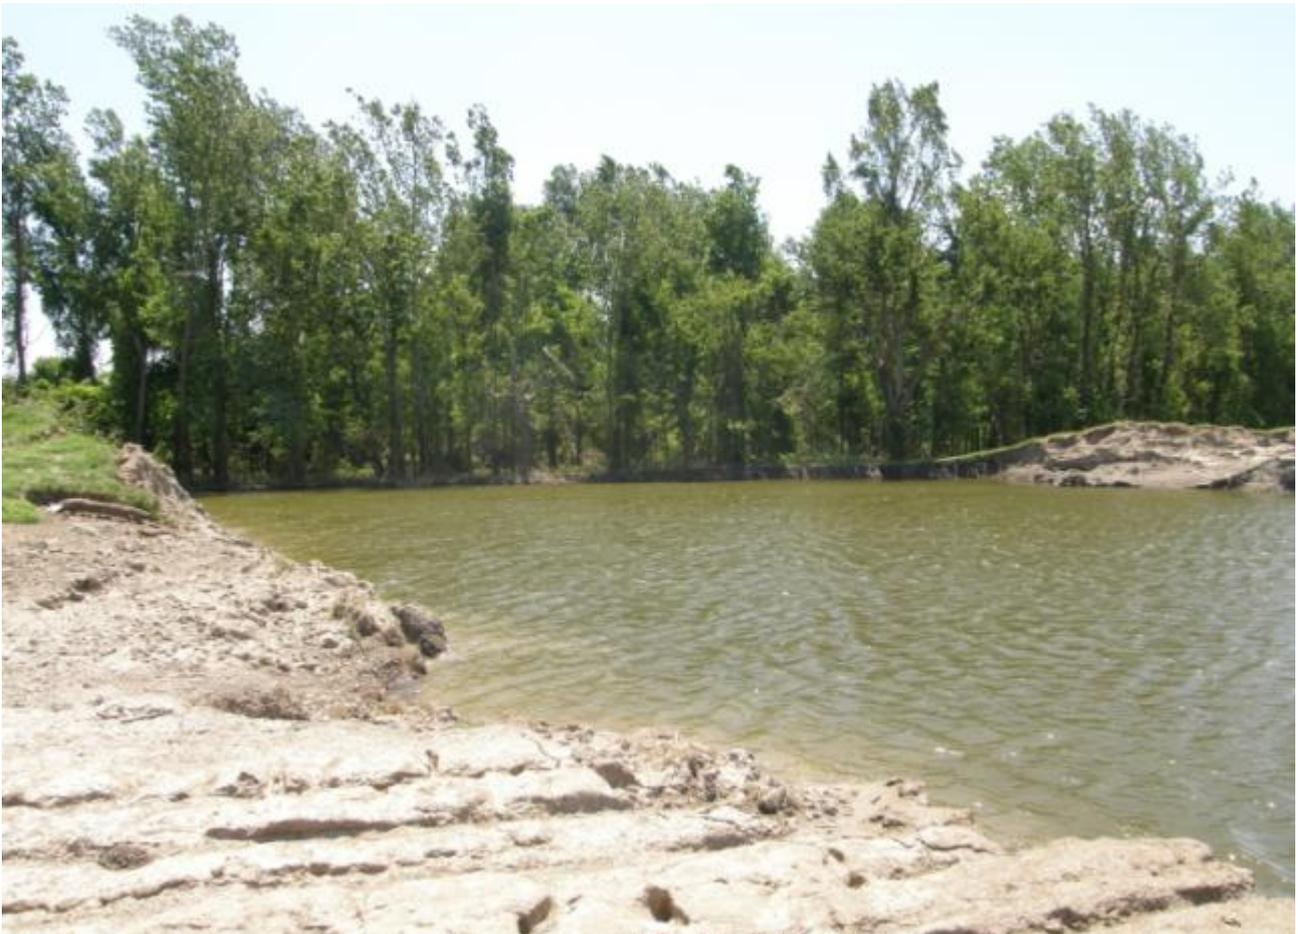
Fig. 10 Birds Point (Missouri) man-induced levee breach.

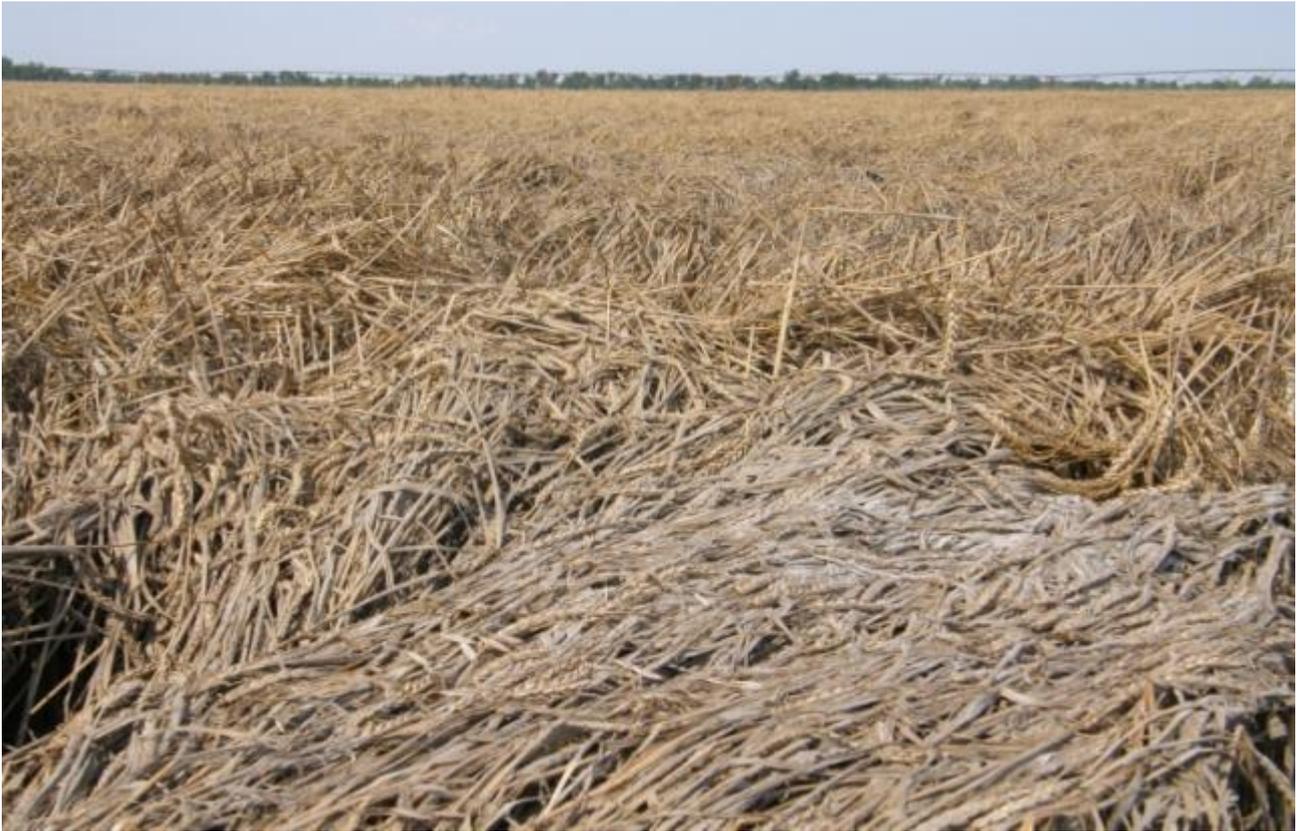
Fig. 11 Drowned wheat crop on May 20, 2011 in Birds Point-New Madrid (Missouri) floodway.

(Fig. 11), delayed planting of soybeans and damage to soil productivity upon which future crops depend. Although some soil damages were expected under flooding conditions, the strong current and sweep of water through the Birds Point breach created deep gullies in several places, displaced tons of soil, damaged irrigation equipment (Fig. 12), farm and home buildings. Extensive excavation of sediment-filled ditches, filling of craters and gullies, incorporation of thin sand deposits into the plow layer of fields and the re-distribution of soil as well as the rebuilding of the levee system were all tasks necessary for Missouri farmers to plant and grow crops in 2012.

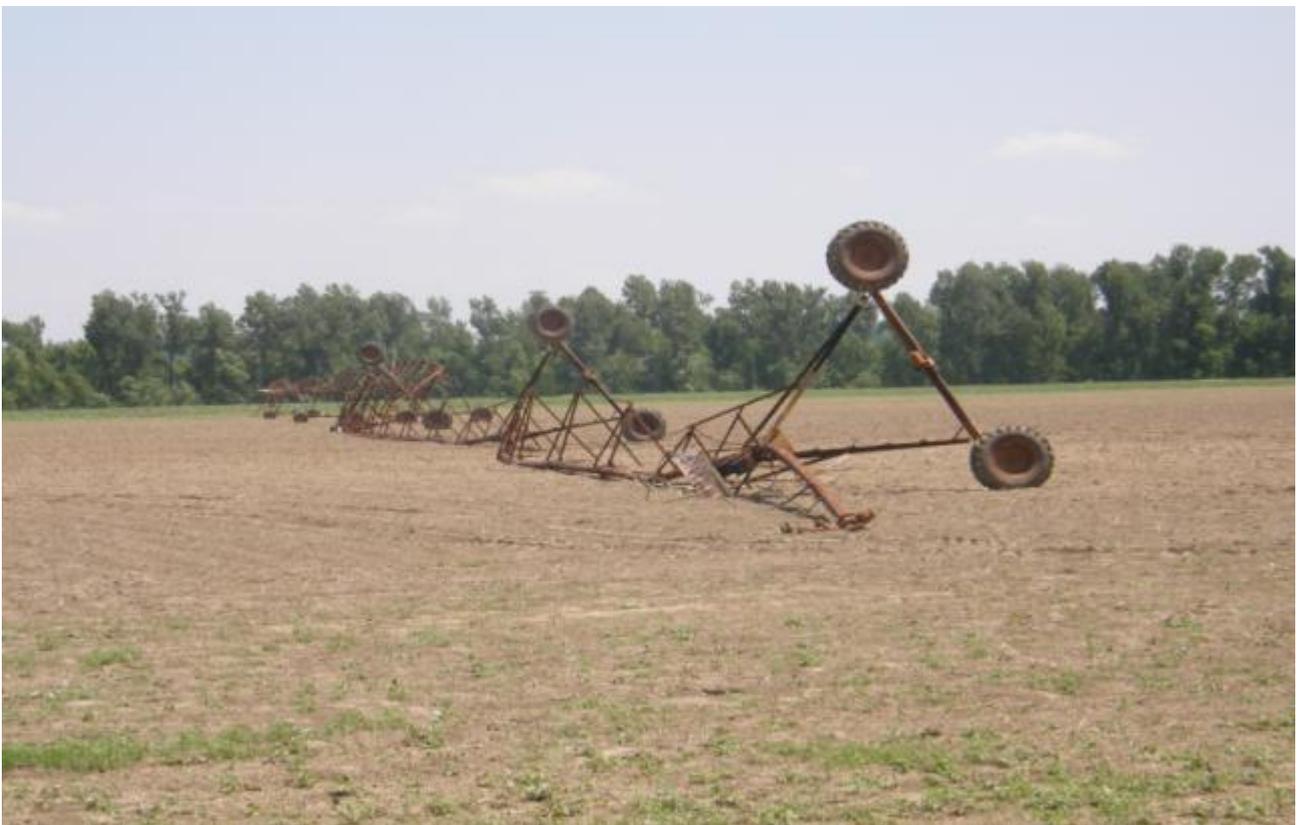
Fig. 12 Toppled irrigation equipment in Birds Point-New Madrid (Missouri) floodway.

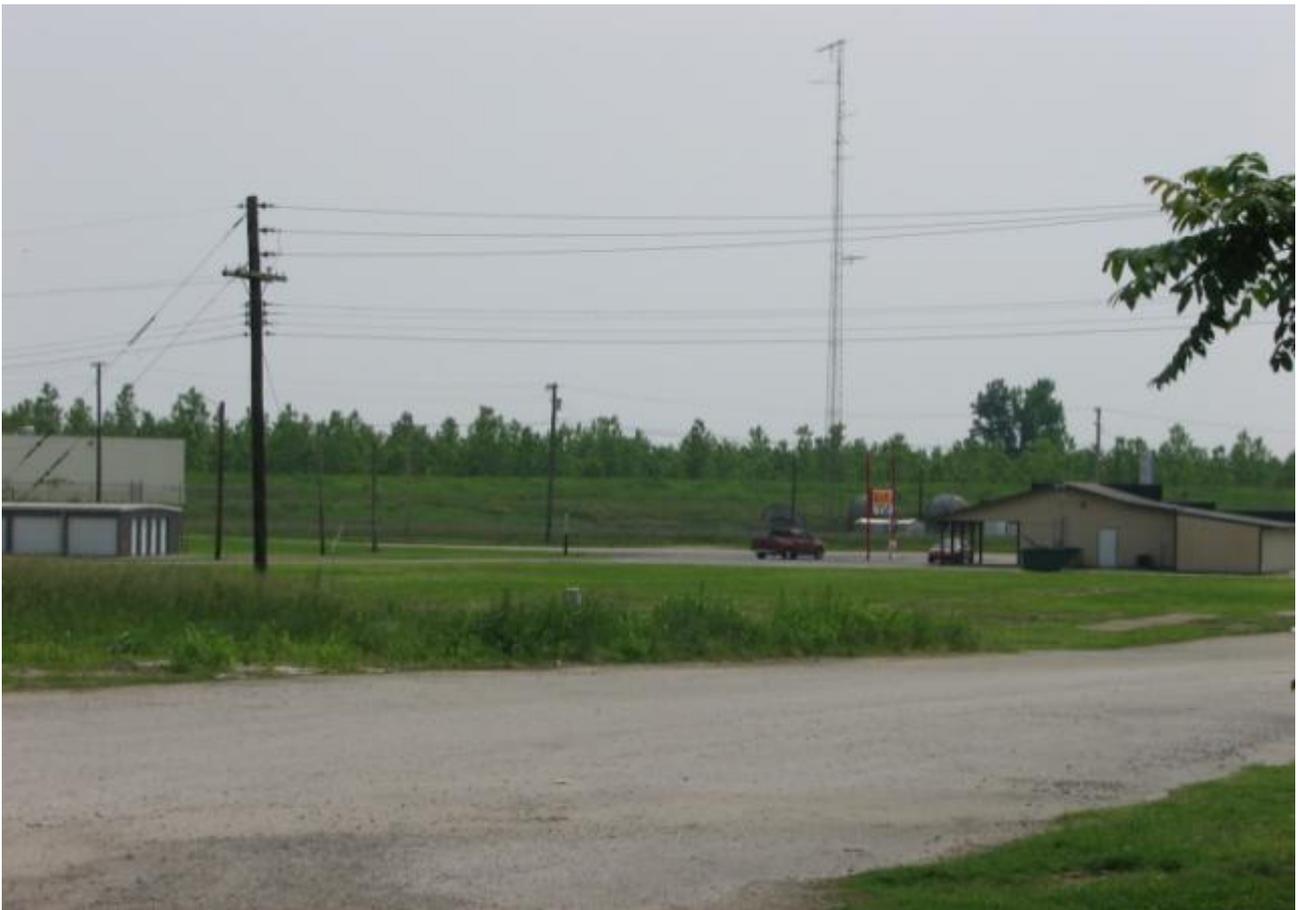
Fig. 13 Cairo (Illinois) levee on Mississippi River.

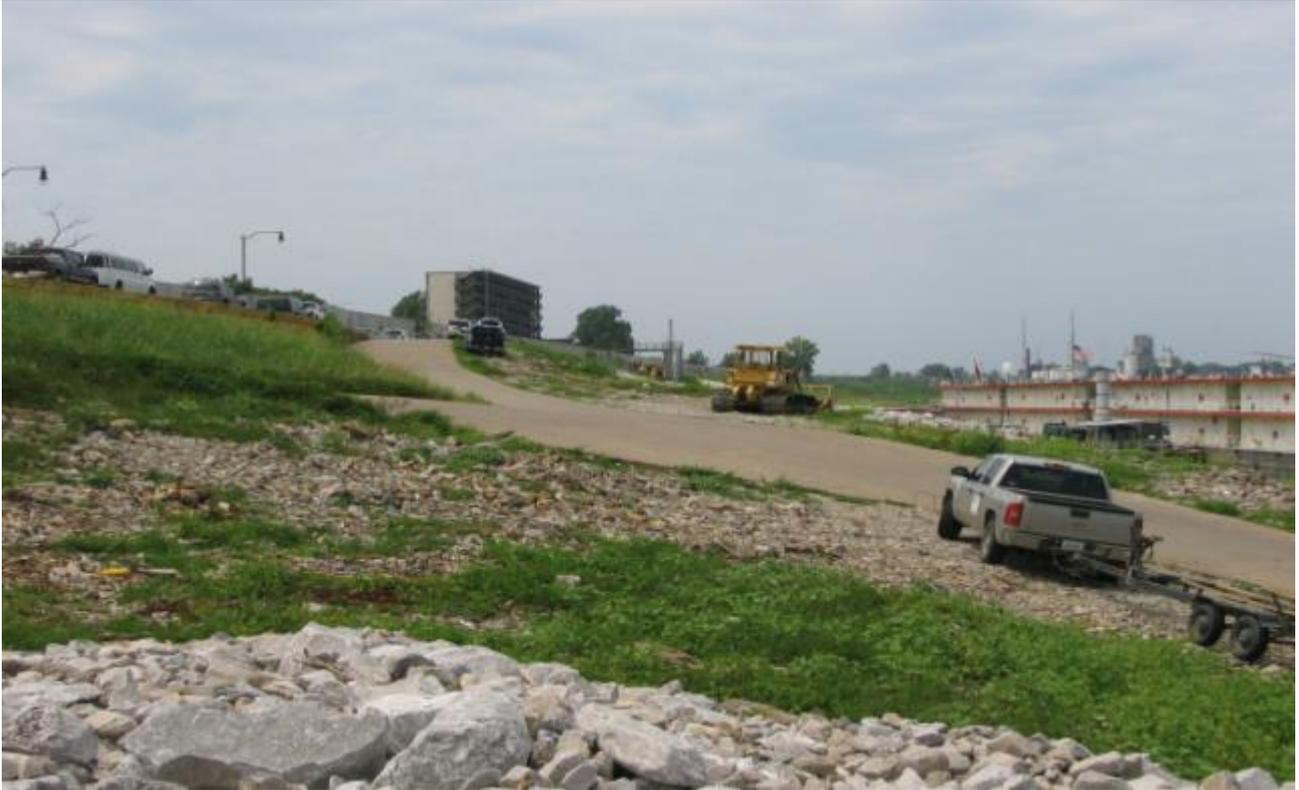
Fig. 14 Cairo (Illinois) floodwall on top of the Ohio River bank.

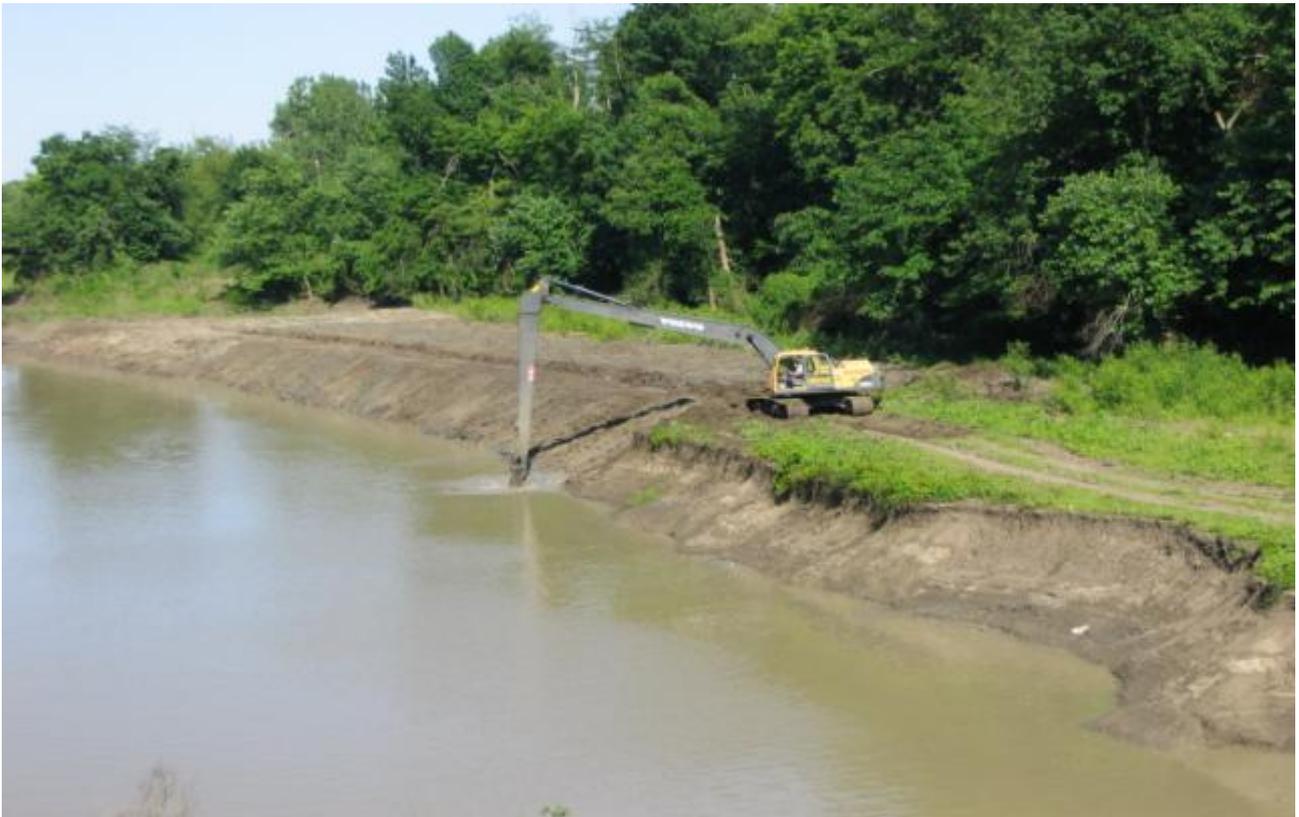
Fig. 15 Sediment removal from main drainage ditch which drains southern 40,000 ha of Birds Point-New Madrid (Missouri) floodway.

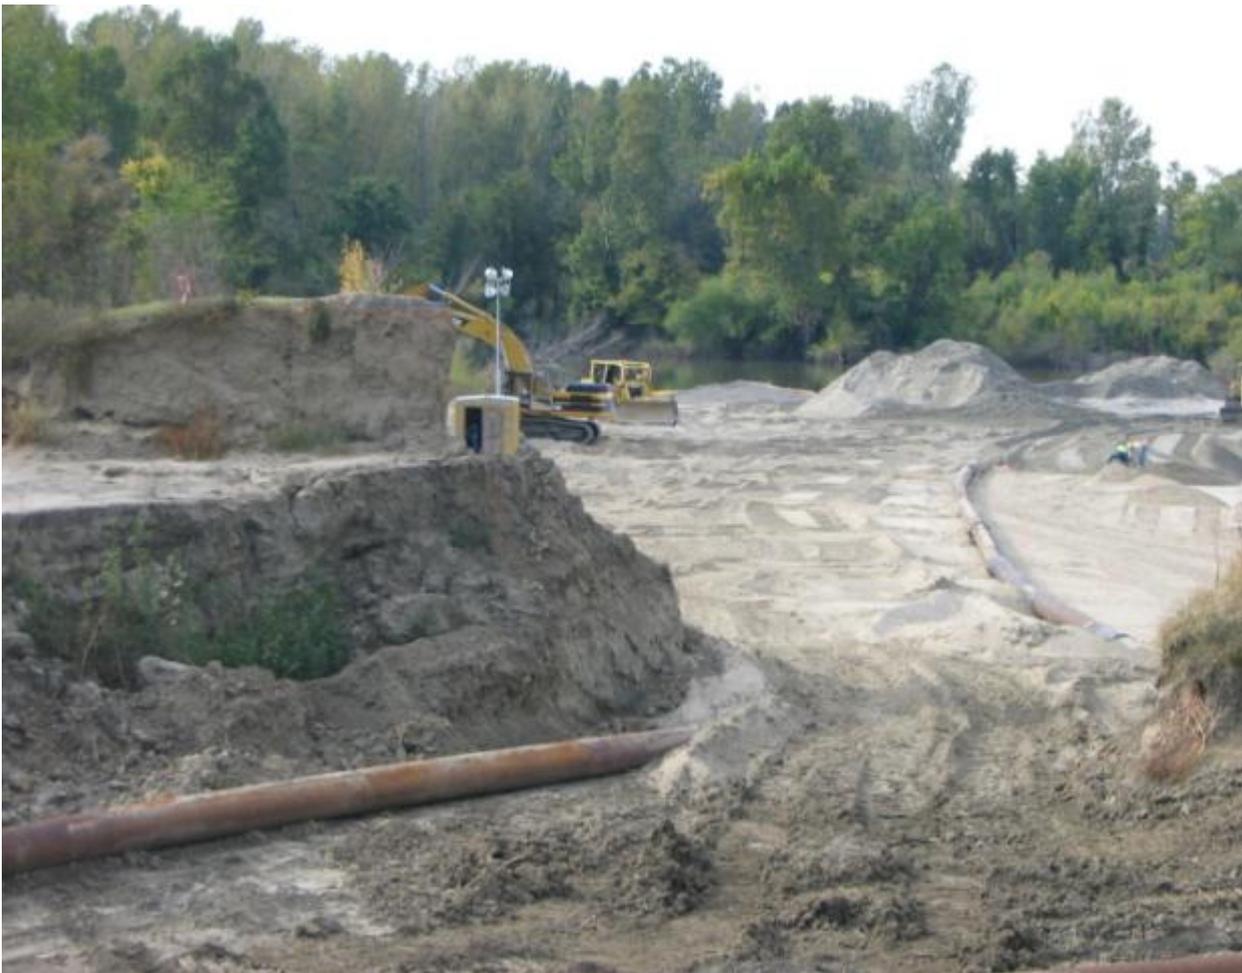
Fig. 16 Ongoing repair of Big Oak Tree (Missouri) frontline levee breach.

in patching the levees (Figs. 16 and 17). The frontline levee near Big Oak Tree State Park had only one 6.4 ha crater lake extending through the levee and a thick 1 m to 2 m deltaic sand deposit approximately 30 ha in size with additional sand deposits between 0.3 m and 2 m and more than 70 ha in size. This thick deltaic sand deposit required removal before the land could be planted to crops. The drainage (Fig. 18) and road (Fig. 19) ditches were filled 0.9 m to 1.8 m of fine sediment and sand.

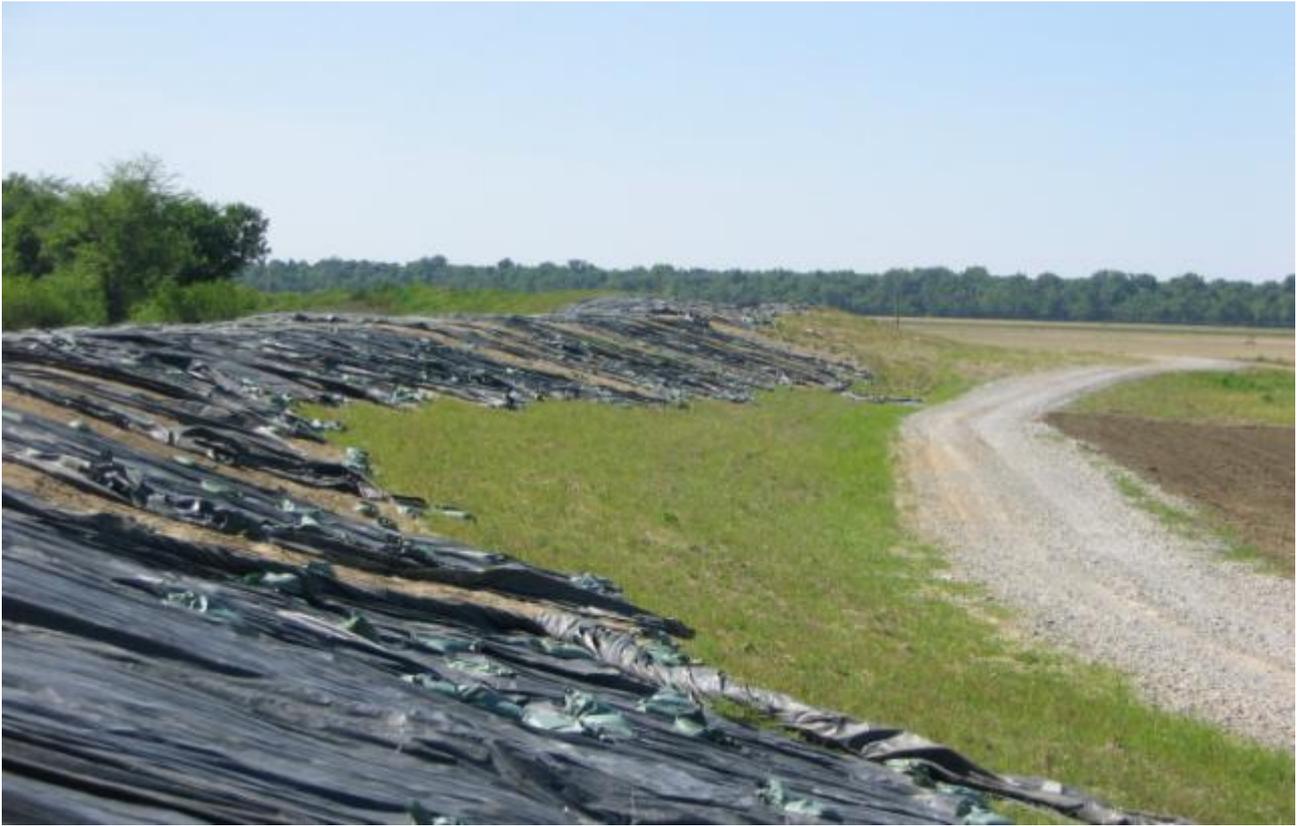
Fig. 17 Completed repair of Big Oak Tree (Missouri) frontline levee with tarp to protect levee during the winter.

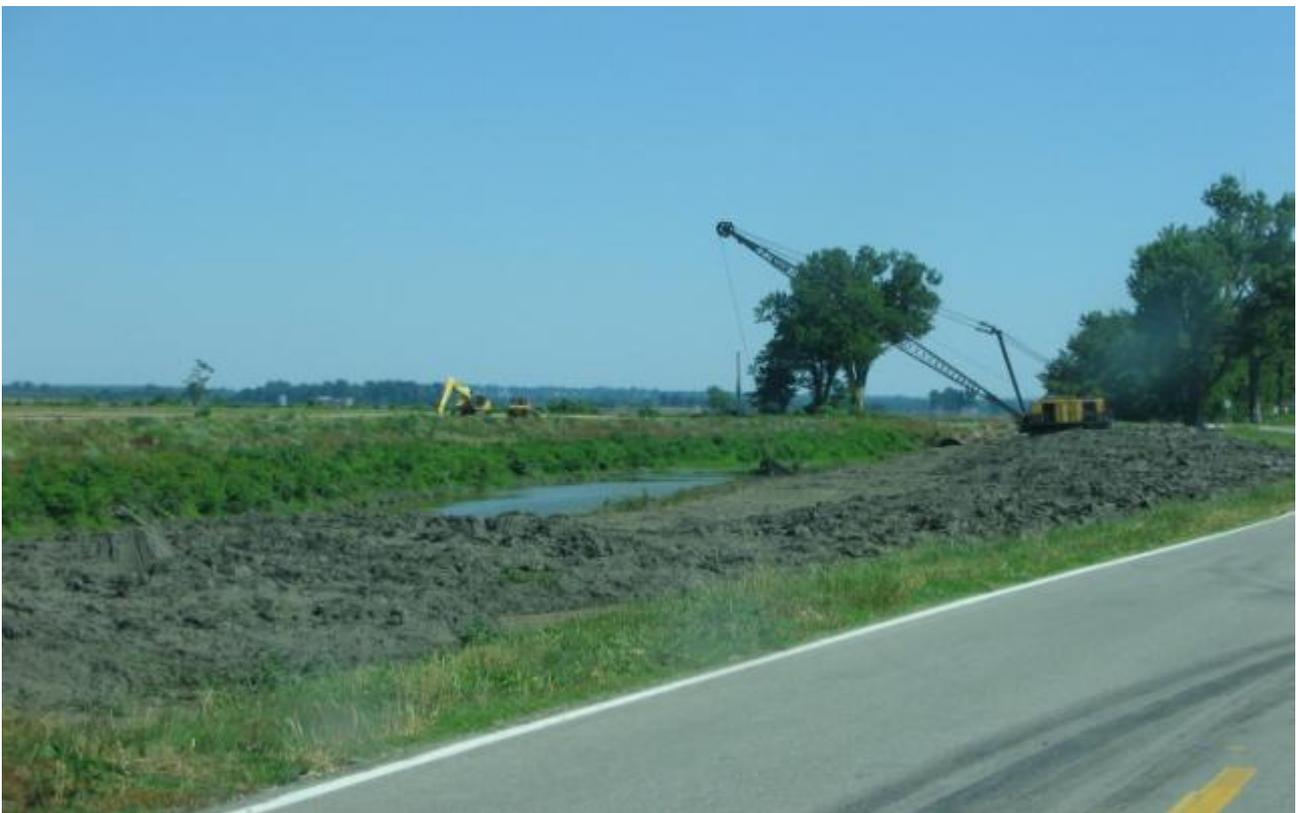
Fig. 18 Cleaning out drainage ditch in Birds Point-New Madrid (Missouri) floodway with drag line.

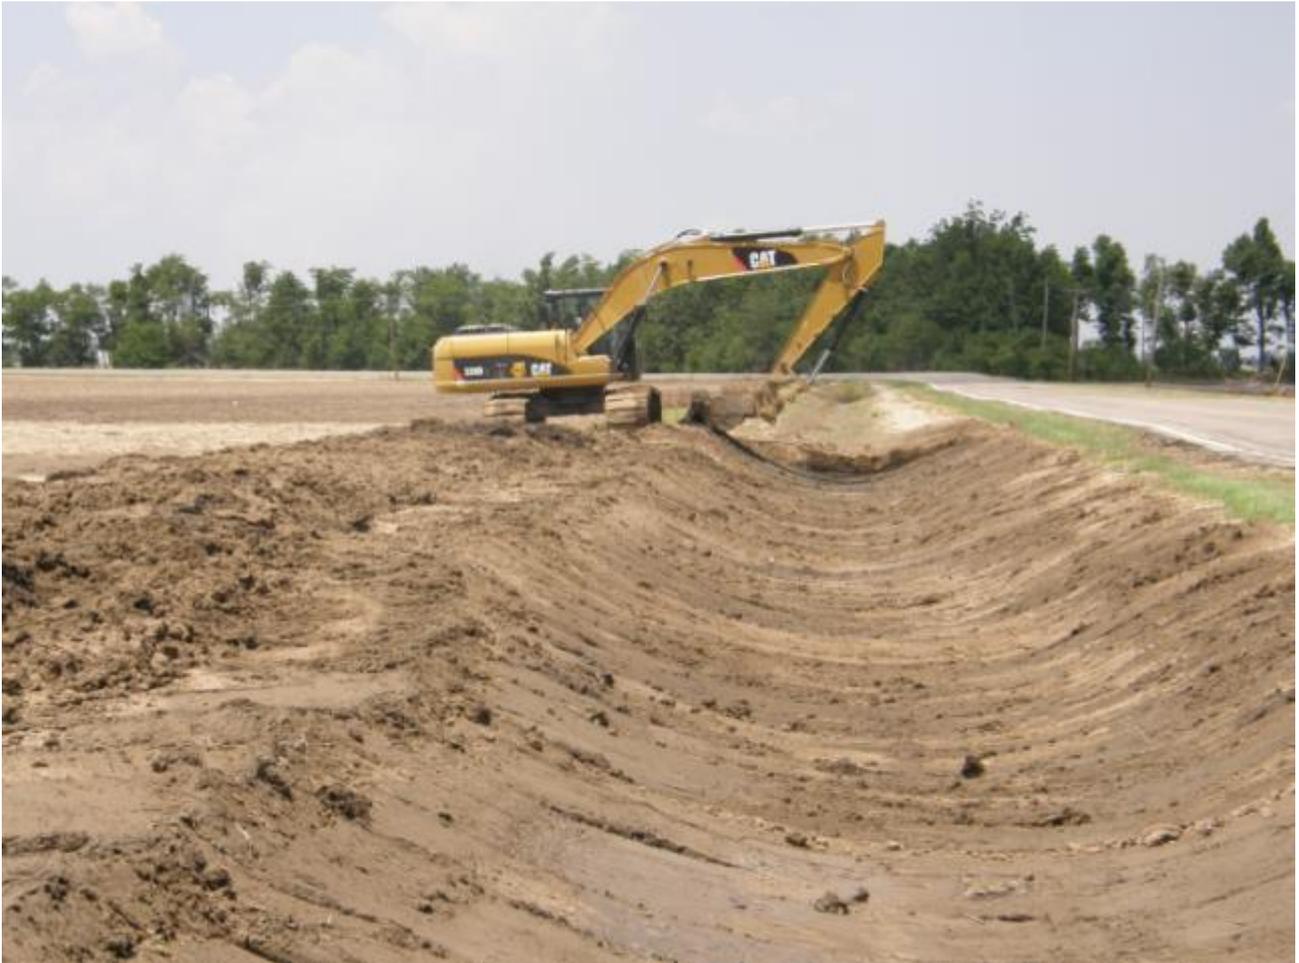
Fig. 19 Cleaning out highway ditch in Birds Point-New Madrid (Missouri) floodway with excavator.

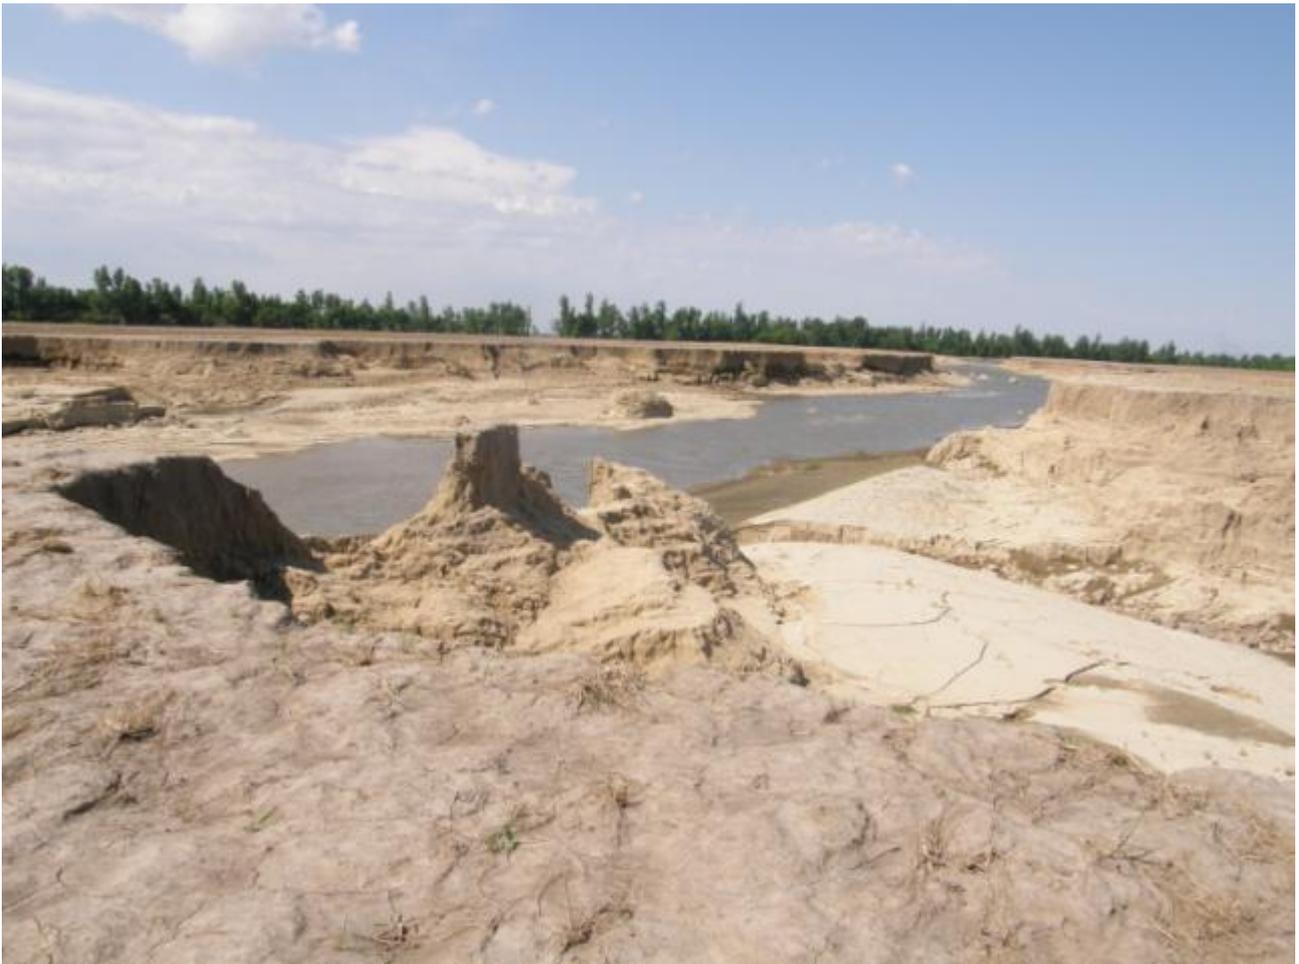
Fig. 20 O'Brien Ridge gully field with canyon sized gullies in Birds Point-New Madrid (Missouri) floodway.

This rapid cutting of floodwater created turbulence and eroded the higher Dubbs and Dundee soils. Once an erosional channel was created, the channel concentrated the water and in some cases up to 1 km long gullies (channels) were created during this one time use of the floodway. Most of these gully fields (Fig. 20) are located 8 km to 16.1 km to the southwest of the Birds Point levee breach. They are not connected to the crater lakes next to the levee breaches. Some of the gullies are 3.7 m deep, 45.8 km wide and 1 km long; and a number of fields had less than 1/2 of each field planted to soybeans in late June and early July of 2011. The force of floodwater which created these large gullies also washed out road beds and road bridges. Further degradation of county roads occurred from trucks hauling soil materials for reconstruction of the area.
